Rotary Park Hydrovac Observation Report

Report Number:	1 Rev.1	Project Name:	Drumheller Spray Park Engineering Design & Construction Support
Date:	March 29, 2022	Project Number:	23.2311.001 (SweetTech)
Report By:	Scott Crawford, EIT	Weather:	1°C to 9°C Sunny and Clear

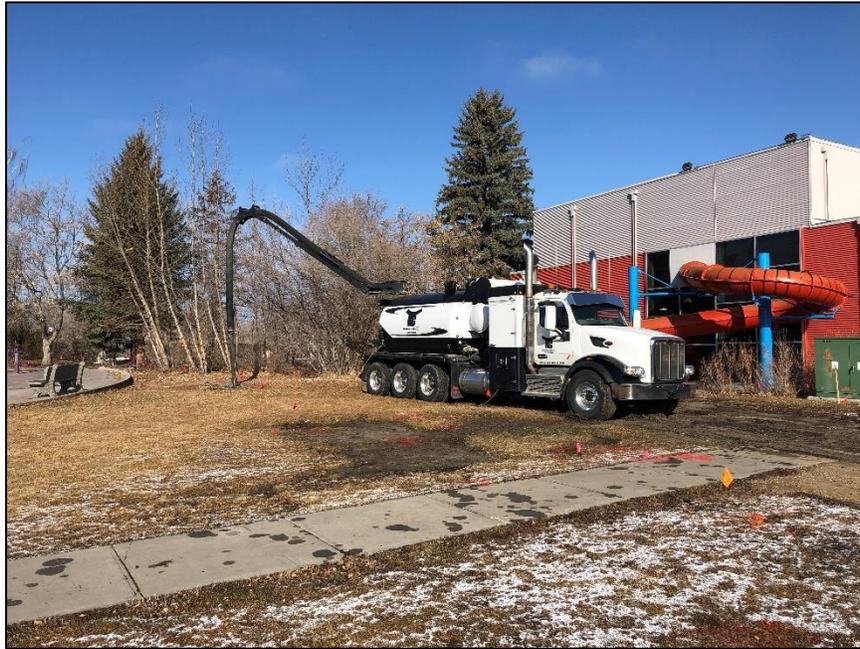
Photo 1: Hydrovac truck setting up for hydrovacating of location 3.

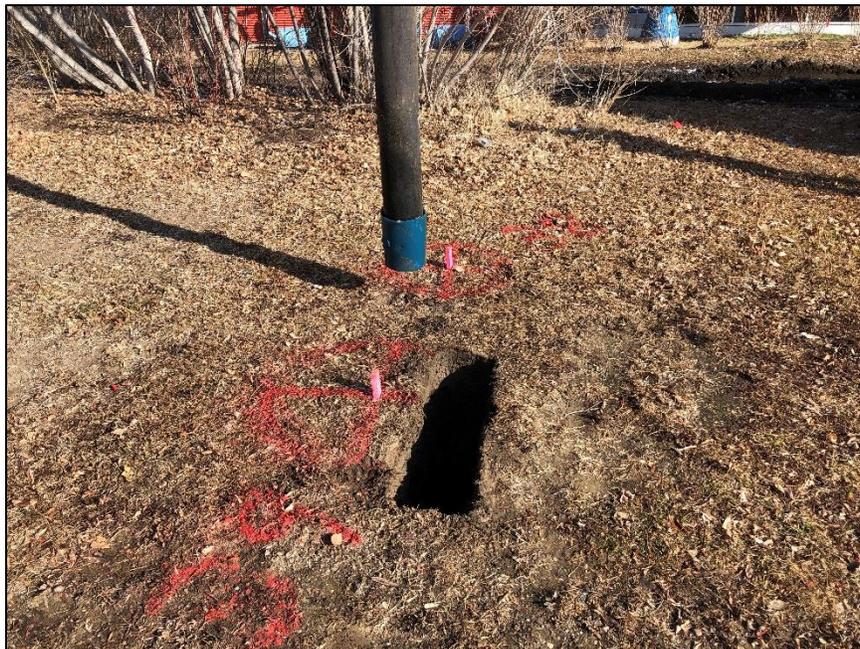
The first area to be hydrovaced was the location of a proposed new manhole for the redesigned drainage. This location is denoted as number 3 on the attached markup, directly north of the spray park concrete pad. The hydrovaced rectangular hole was approximately 1 m long by 0.25 m wide. Hydrovacing at this location revealed concrete rubble and abandoned wiring above the existing ATCO lines. These materials are suspected to be components of the former pump house that previously resided in the area. The hole terminated at a depth of approximately 1.25 m, two ATCO lines surrounded by plastic conduit were located.

Photo 2: Hydrovaced hole at location 3.

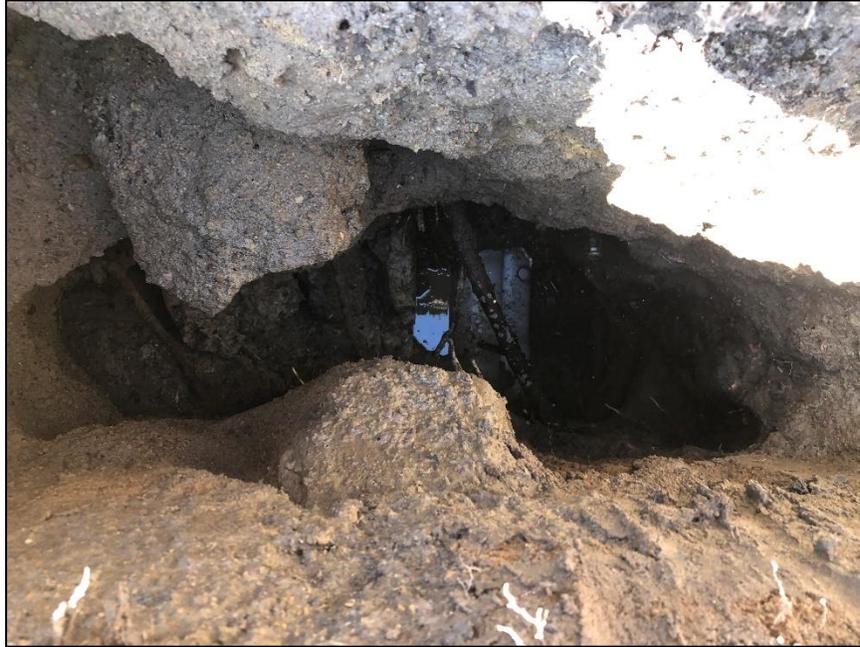
Photo 3: Exposed ATCO utility conduits at location 3. Concrete rubble and abandoned wires above and around the conduit. Photo taken facing East.

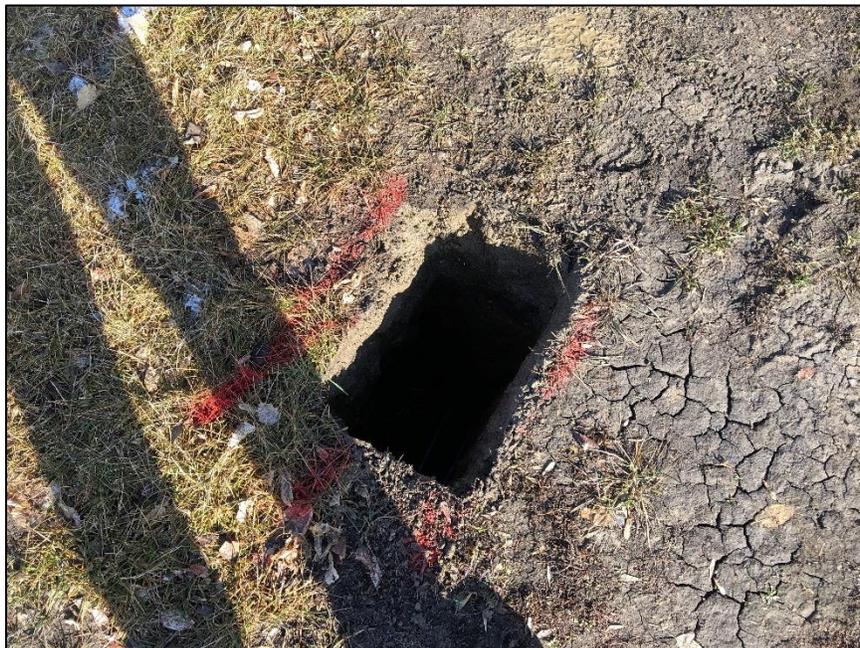
The second location to be hydrovaced was just south of the transformer box next to the aquaplex, denoted by number 2 on the markup. The hydrovaced rectangular hole was approximately 0.6 m long and 0.3 m wide. There were no anomalous materials found during hydrovacing at this location. The hole terminated at a depth of approximately 1.20 m where two ATCO lines surrounded by plastic conduit were located.

Photo 4: Hydrovaced hole at location 2.

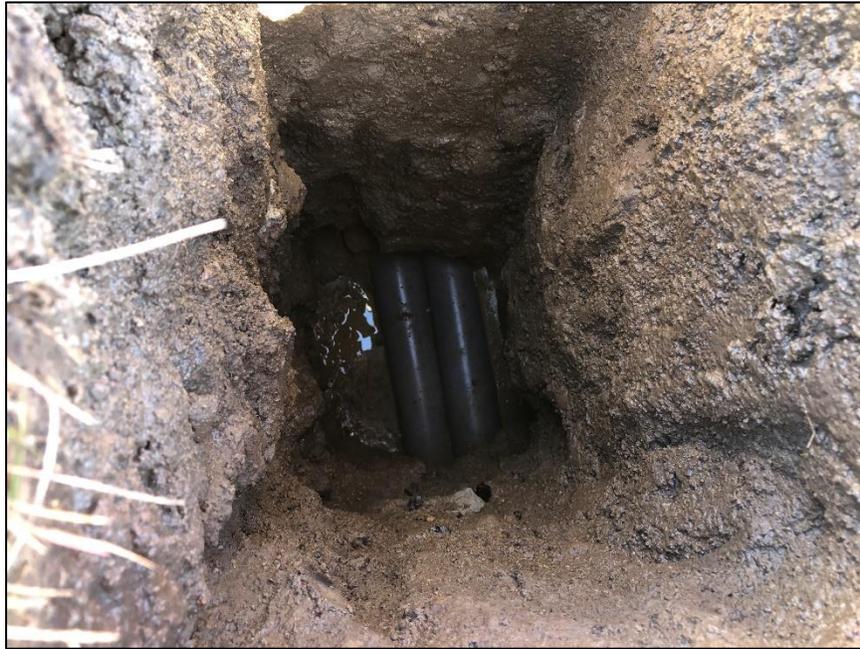
Photo 5: Exposed ATCO conduits at location 2. Photo taken facing East.

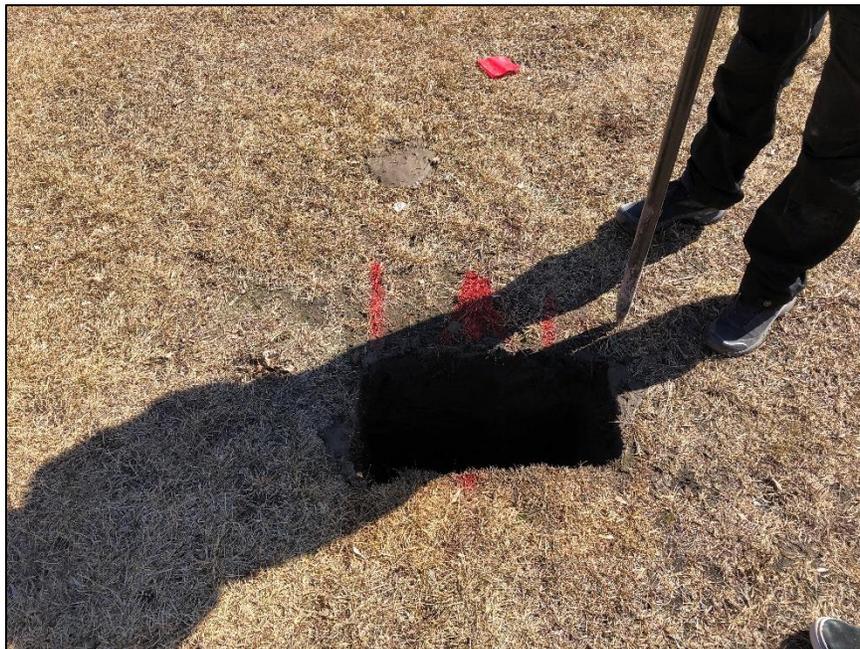
SweetTech requested an additional hydrovac location to confirm the alignment of the ATCO line as it travelled east, out of the park and towards the existing parking lot. A location was chosen just west of the parking barricades separating the sidewalk and the park, where the existing ATCO line intersected the existing AltaGas Line. This location is clouded and labelled number 1 on the attached markup. The hydrovaced rectangular hole was approximately 0.6 m long and 0.3 m wide. There were no anomalous materials found during the hydrovacing at this location. The hole terminated at a depth of approximately 1 m, two ATCO lines and one AltaGas line were located. All the lines were surrounded in plastic conduit.

Photo 6: Hydrovaced hole at location 1.

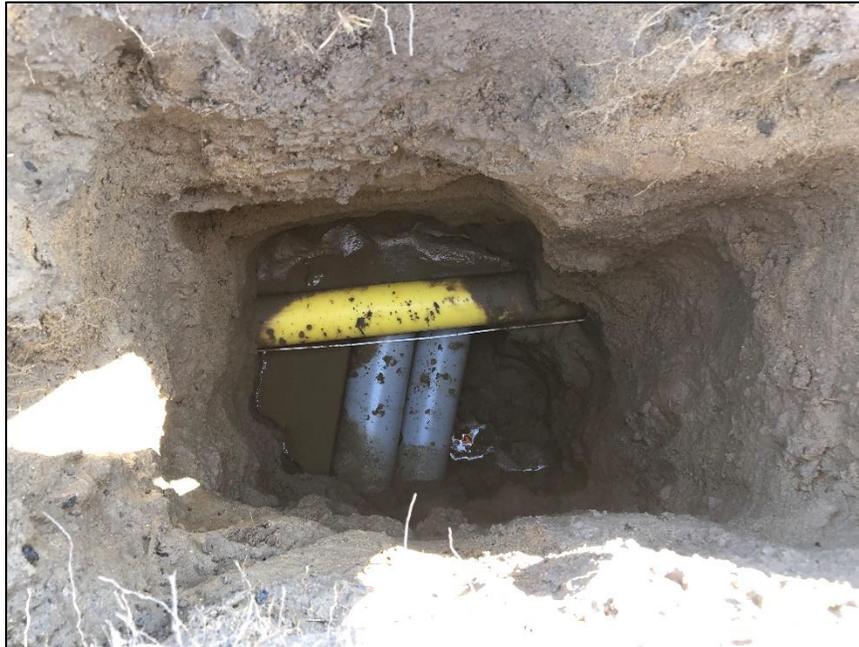
Photo 7: Exposed ATCO and AltaGas utility conduits at location 1. ATCO conduits in grey, AltaGas in yellow. Photo taken facing East.

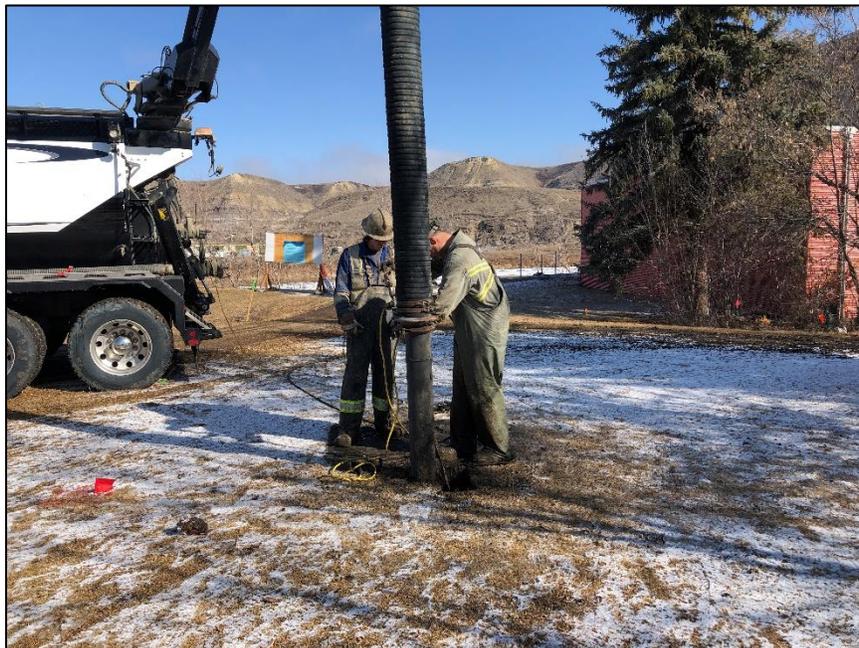
Photo 8: KC Hydrovac employees hydrovacating at location 4.

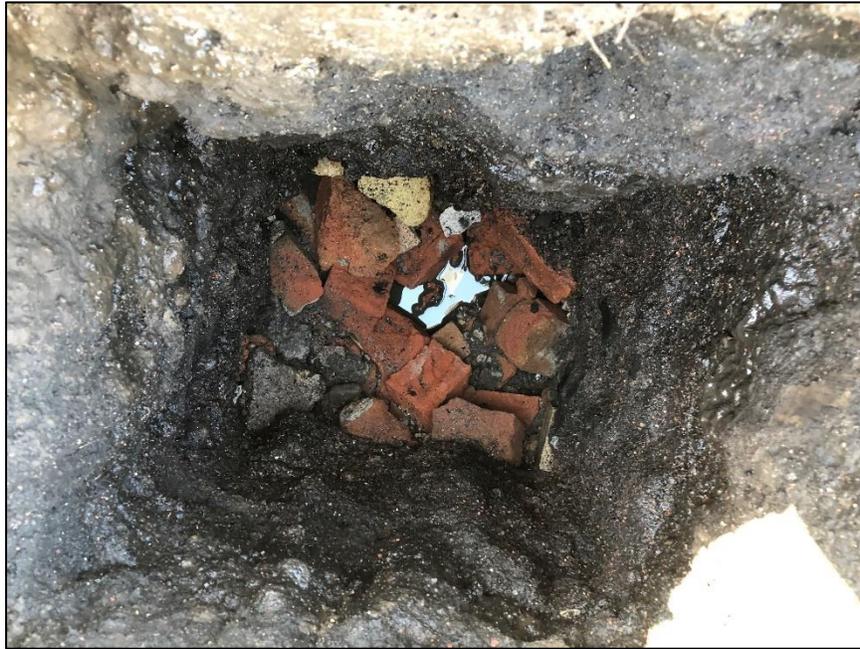
was approximately 1 m long and 0.6 m wide. The hole was slightly irregular in shape, as hydrovacing at this location proved difficult due to the discovery of unexpected, buried objects: a number of red clay bricks were exposed at approximately 0.5 m below the surface, and these bricks continued to appear scattered throughout the dig as depth increased. It is unknown what these bricks were historically a component of, as this location was between the historic pump house and substation footprints. At a depth of approximately 1.4 m, a single ATCO line was located, surrounded by plastic conduit.

Photo 9: Red clay bricks at approximate depth 0.5 m while hydrovacating at location 4.

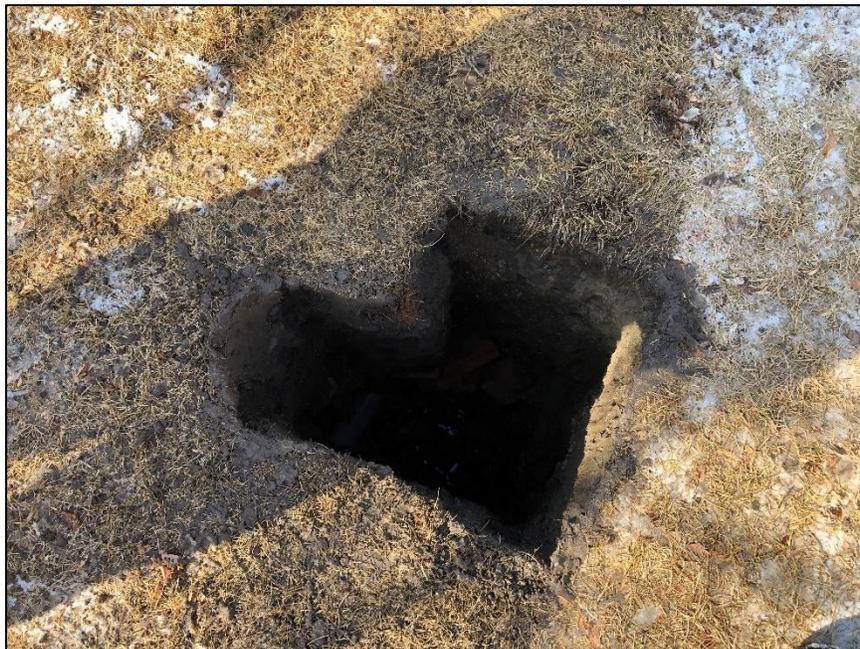
Photo 10: Hydrovaced hole at location 4.

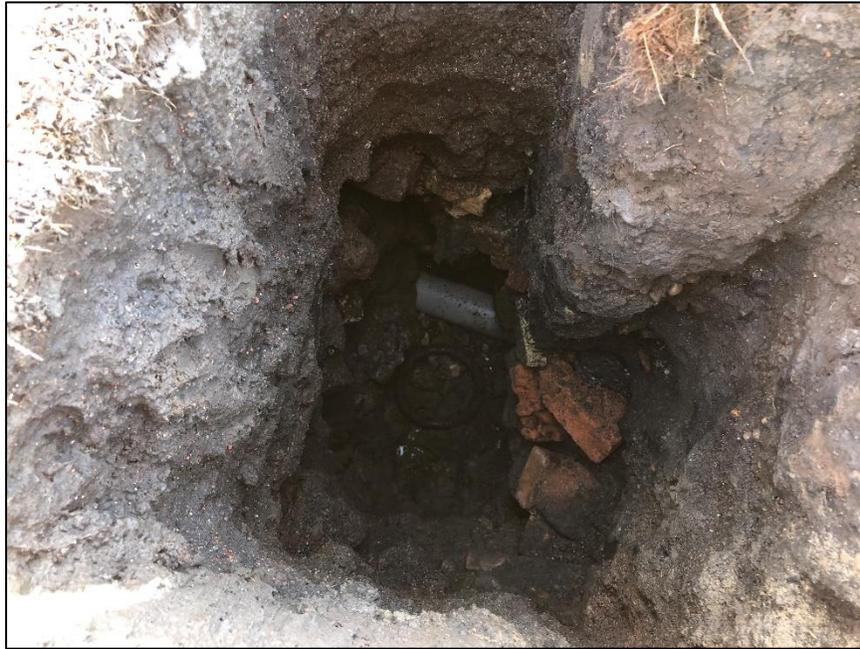
Photo 11: Exposed ATCO utility conduit at location 4. Red clay bricks seen in the excavated hole. Photo taken facing South.

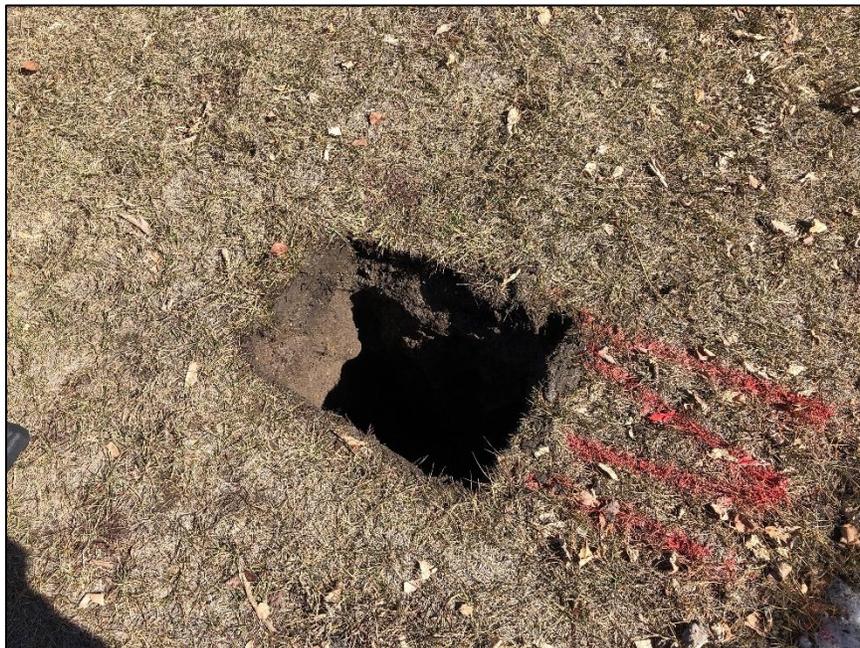
The fifth and final hydrovac location was at the southmost fence line of the park, denoted by cloud 5 on the markup. The hydrovaced rectangular hole was approximately 0.6 m long and 0.3 m wide. During hydrovacing at this location, a small number of red clay bricks were exposed. It is likely these bricks were components of the demolished and buried plant structure that used to be in the area. At a depth of approximately 1.4 m, two ATCO lines surrounded by plastic conduit were located.

Photo 12: Hydrovaced hole at location 5.

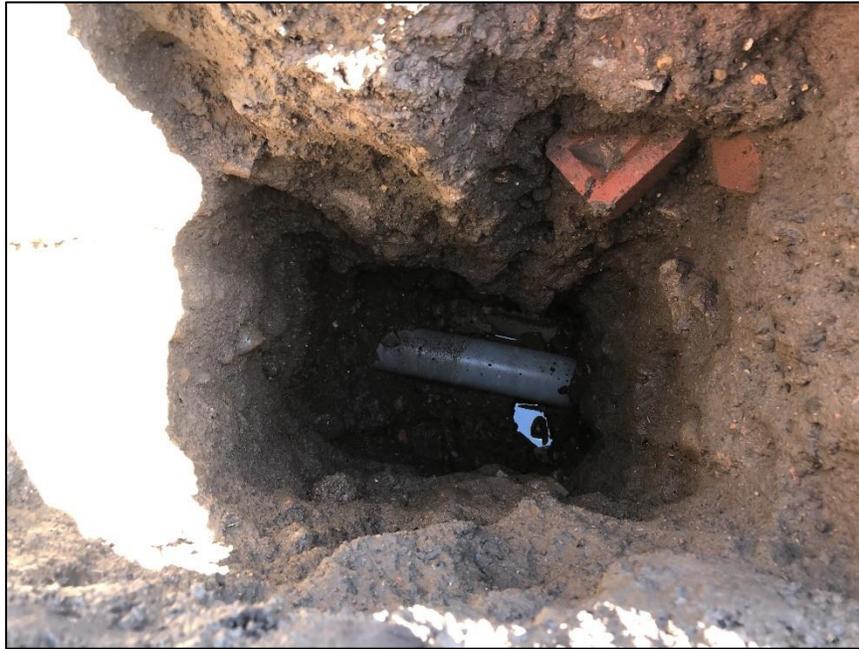
Photo 13: Exposed ATCO utility conduits at location 5. Red clay bricks seen in the excavated hole. Photo taken facing East.

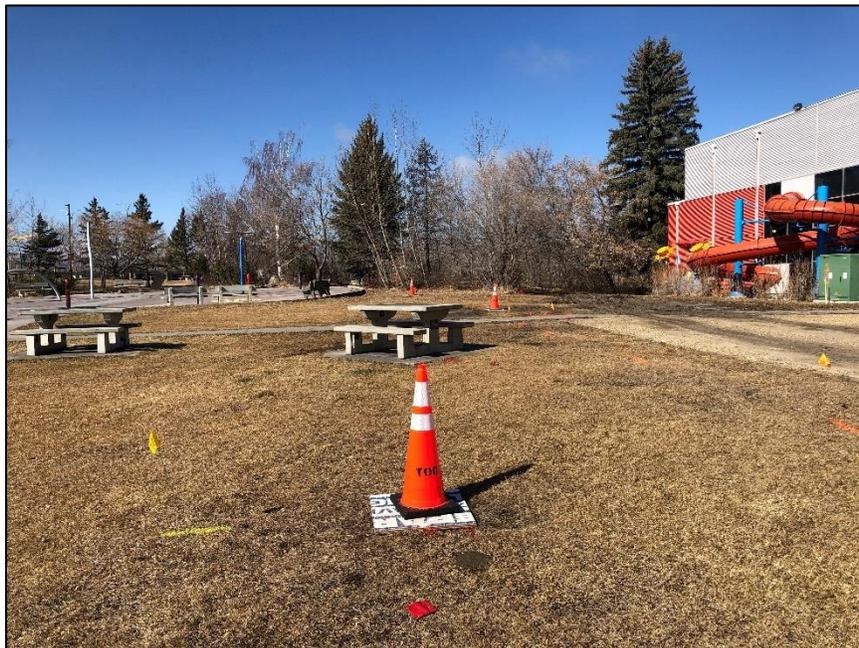
Photo 14: Plywood boards and construction cones placed on top of hydrovaced holes while waiting for survey to arrive.

Between the hydrovacing of the fourth and fifth holes, SweetTech spoke to Kevin Blanchett (Town of Drumheller) and communicated the need for plywood and cones to cover the hydrovac holes until the exposed utilities had been surveyed and the holes could be backfilled. A laborer from the town delivered these boards and cones, and the previously dug holes were covered and marked for safety.

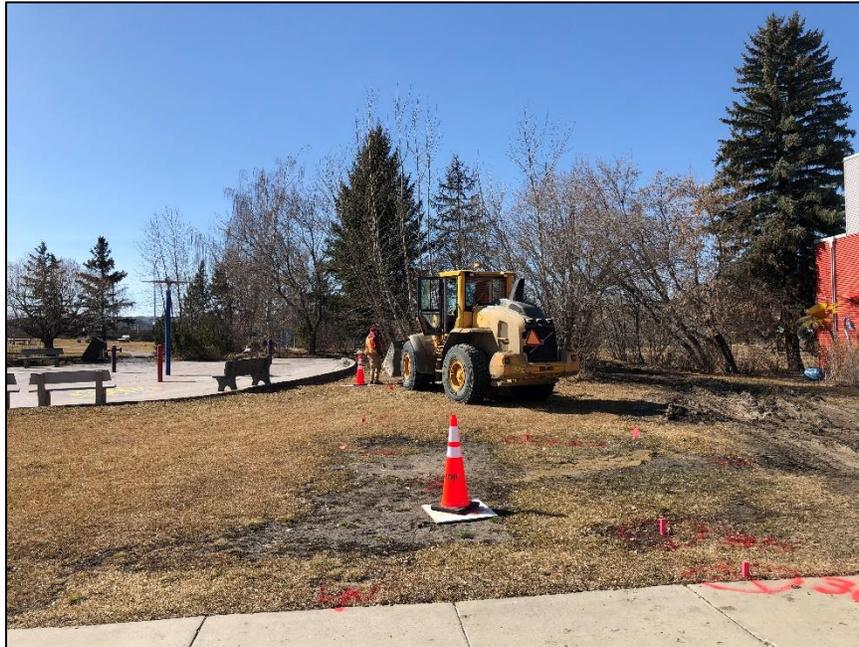
Photo 15: Town of Drumheller backfilling the hydrovaced holes with sand using shovels and a Volvo compact wheeled loader.

At approximately 2:00 pm, two laborers from the Town of Drumheller arrived on site with a Volvo compact wheel loader with a bucket full of bedding sand. It was communicated to SweetTech by the Town that the holes would be filled with sand, allowed to settle, and then laborers would return and re-fill any slumped holes with topsoil as needed. Laborers completed backfilling the final hole at approximately 2:30 pm, and left site at 3:00 pm after using the remaining sand to even out ruts in the parks access road.

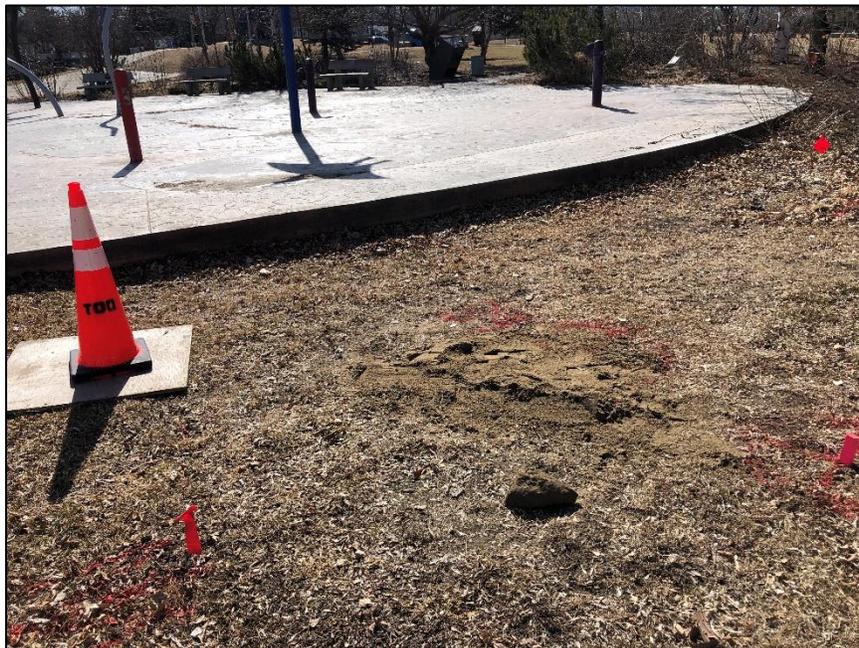
Photo 16: Hydrovaced hole at location 3 backfilled with sand.
