DRUMHELLER  
VALLEY

## DRFM Dike D - Geotechnical Investigation Report

FINAL - REVISION NO. 0

Issue Date: September 17, 2021

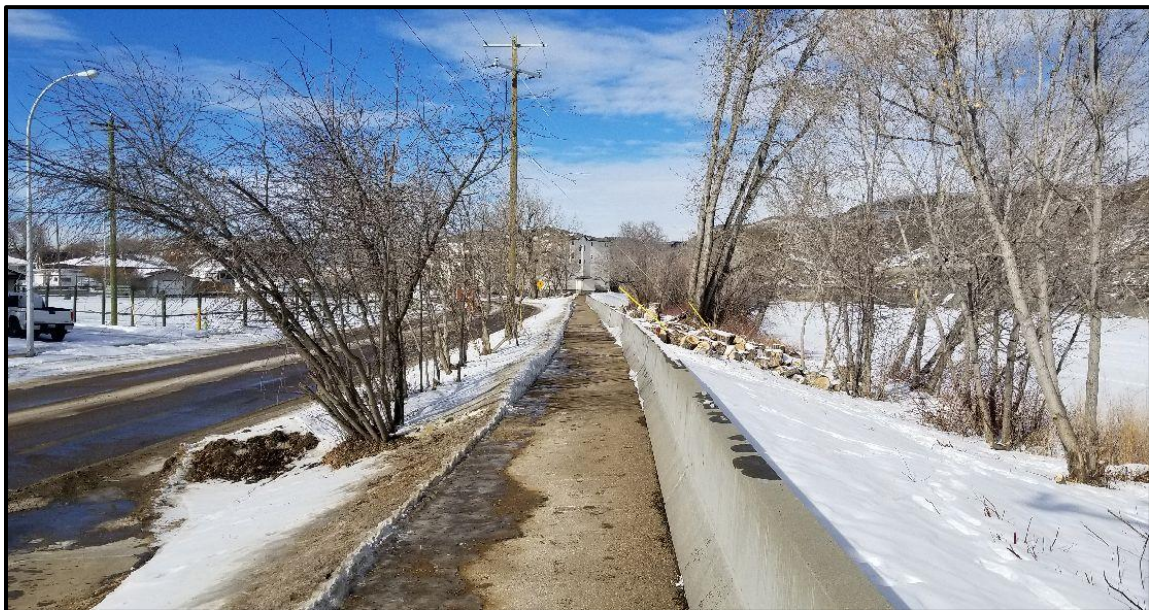
Image 1 - Riverside Drive Conflict Area

the river. The flood barrier along Riverside Drive is currently constructed of concrete jersey barriers with a narrow (<2 m wide) walking path beside it. The portion of the dike alignment with jersey barriers is located between dike station D 0+806 to station D 1+100. If the typical dike detail (trapezoidal 3H:1V side slopes) is utilized in this area and instream river work is to be avoided, the entire width of Riverside Drive falls within the proposed dike footprint. As such, preliminary options for the Aquaplex and Riverview Terrace Condominiums involves the construction of a retention system on the landside of the dike to reduce the proposed footprint. Along Riverside Drive preliminary options include the construction of retaining walls, a combination of retaining walls and reconfiguring Riverside Drive and complete removal of a portion of Riverside Drive to allow for the typical dike section to be constructed. The specific layout, design details and materials for these areas have yet to be selected and further design and decision making from IBI Group and the DRFM is required prior to proceeding with the detailed design for these specific areas.
